Subject: Phase IA Cultural Resources Review  
Ringwood Mines/Landfill Superfund Site  
OU-2 Remedial Design  
EPA ID No. NJD980529739

**Phase IA Background Review and Archaeological Assessment  
Ringwood Mines/Landfill Superfund Site Operable Unit 2**

### **Phase 1A Background Review and Archaeological Assessment Ringwood Mines/Landfill Superfund Site Operable Unit 2 Borough of Ringwood, Passaic County, New Jersey USEPA ID No. NJD980529739**

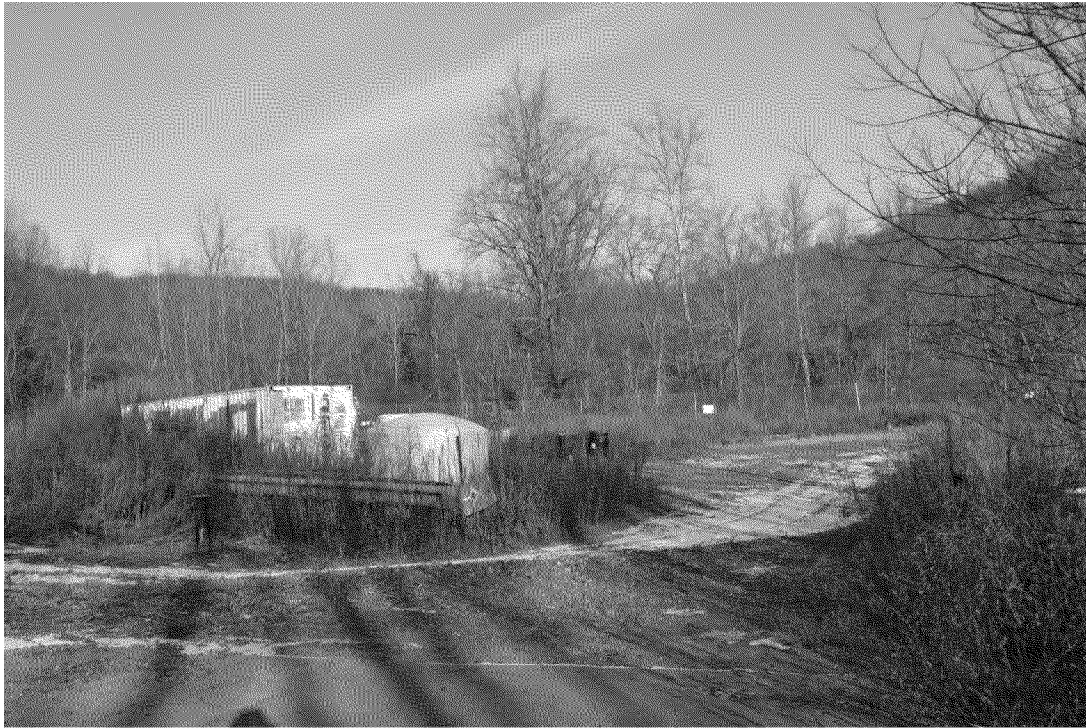
**Photograph 1.** PMP Area--Looking northwest from the end of the pavement on Peters Mine Road. The open area in the foreground is the planned staging area and the fenced area behind it is mine pit area where remediation and construction of a cap will occur. Photo by C.L. Borstel, Tetra Tech, Inc., January 16, 2017.

The main staging area for remediation activities in the vicinity is an open area located at the end of the paved part of Peters Mine Road. The staging area is relatively flat and appears to have been heavily utilized or graded over a considerable period of time. No standing ruins or foundations were observed within this part of the PMP Area.

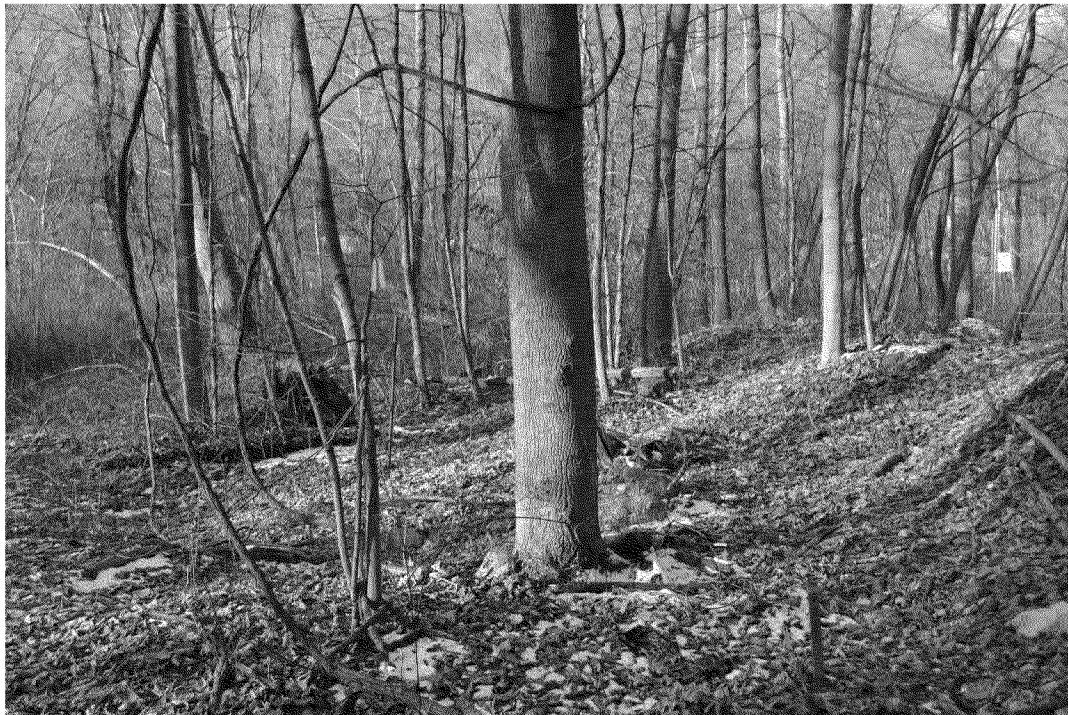
**Photograph 2.** PMP Area—Typical landscape of terrain in remediation area. Looking northeast. Photo by C.L. Borstel, Tetra Tech, Inc., January 16, 2017.

The surface in the immediate vicinity of the PMP is hummocky from a combination of landfill debris (e.g., tires, metal, occasional masonry, bottle glass, upholstery, etc.) and rocks or rock piles. The hummocky terrain

is chaotic and lacked any evident patterning. Remediation activities have previously taken place in the PMP Area, as evidenced by, among other observations, several strips of disturbed, partially revegetated land. Three partial or complete cast-in-place concrete foundations were observed. Two partial or complete foundation slabs were along the southeastern perimeter of the fenced area, while the third (only partially preserved) was situated near the western fence line at the base of the hillslope below the main 1940s-era concrete ruins. No structural elements remained above any of the foundations. Mapping by Edward Lenik (1999: Figure 25) indicates that the buildings in this area were secondary structures of limited importance to mining operations. Field observations and examination of aerial photographs from the 1960s and 1970s lead to a similar interpretation.

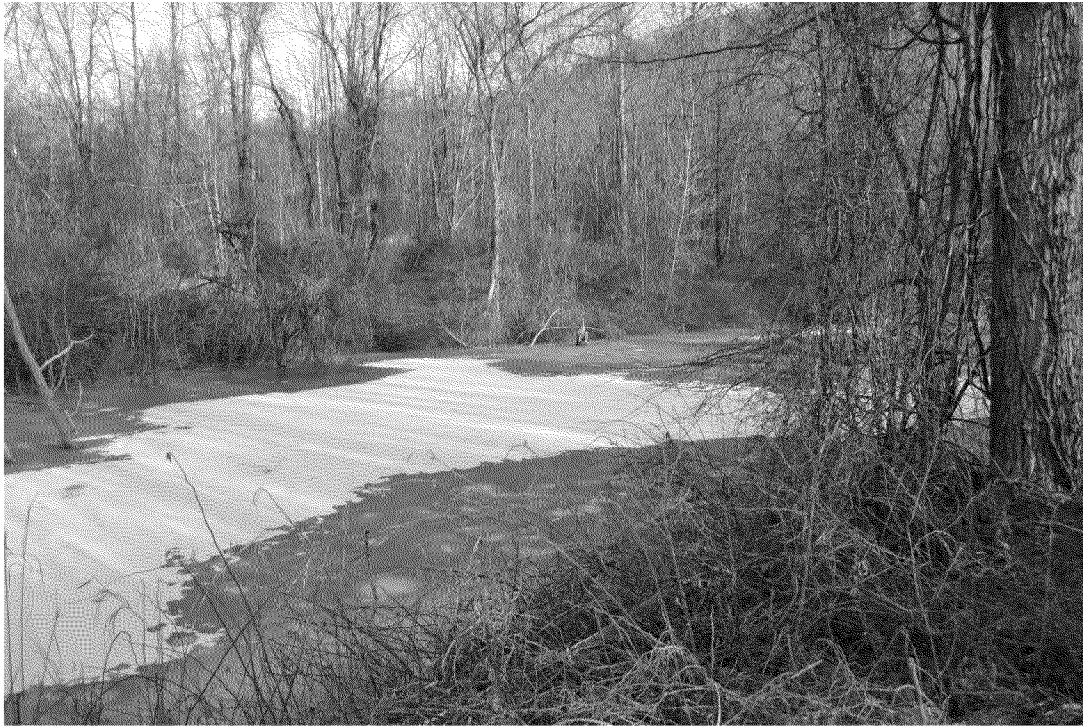
**Photograph 3.** PMP Area—PMP pond in the middle of the remediation area. Looking south. Photo by C.L. Borstel, Tetra Tech, Inc., January 16, 2017.

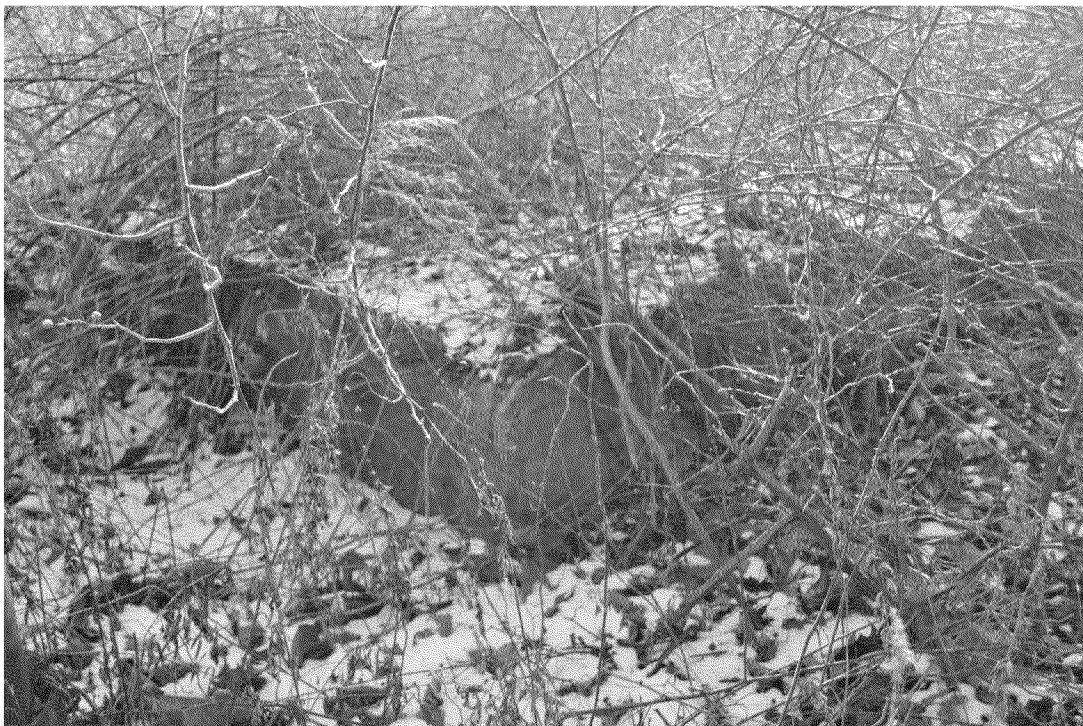
**Photograph 4.** PMP Area—Poured concrete building foundation near the southeastern edge of the remediation area. The foundation was built as part of the U.S. government rehabilitation of Peters Mine during the Second World War. Looking southwest. Photo by C.L. Borstel, Tetra Tech, Inc., January 16, 2017.

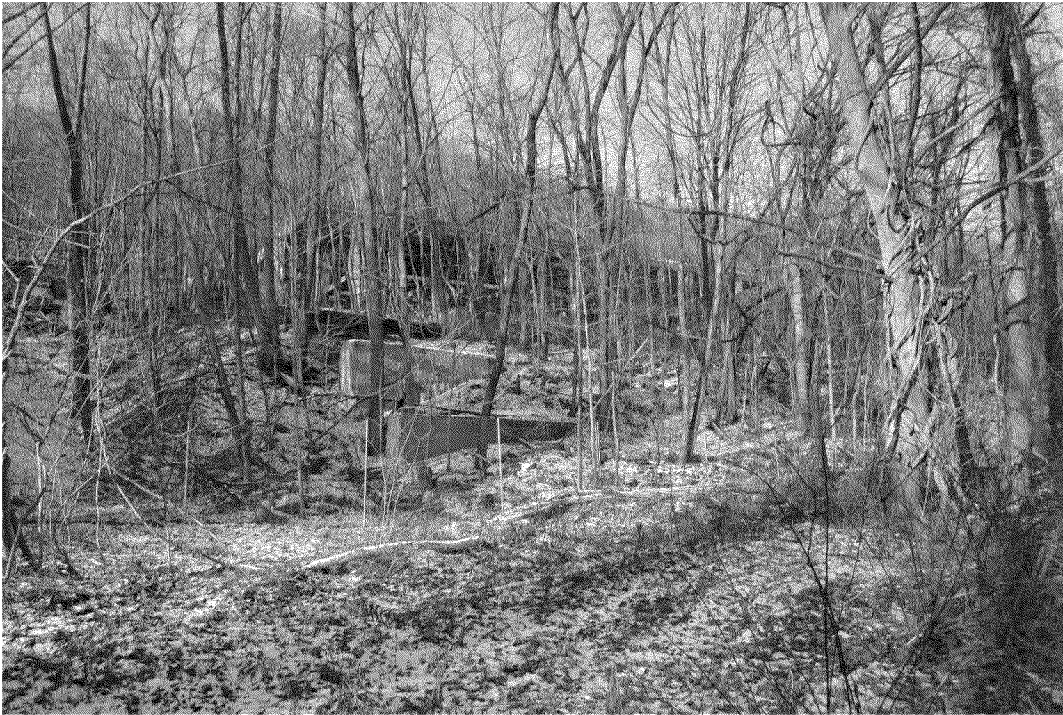
**Photograph 5.** PMP Area—View from southwestern side of remediation area toward ruins of Peters Mine aboveground building complex on hillslope above mine pit. These ruins are the remains of the U.S. government rehabilitation of Peters Mine in 1942-1943 and are outside the remediation area. Looking southwest. Photo by C.L. Borstel, Tetra Tech, Inc., January 16, 2017.

The remedial action and restoration plans for the PMP Area focus on the former open mine pit, but are not concerned with the 1940s-era ruins of mine buildings on the hillslope southwest of the pit, nor with the abandoned underground mine shafts. After remediation is complete at the PMP Area, vegetation restoration will be completed both on the cap and in the immediately surrounding area, including the staging area at the end of the paved portion of Peters Mine Road.

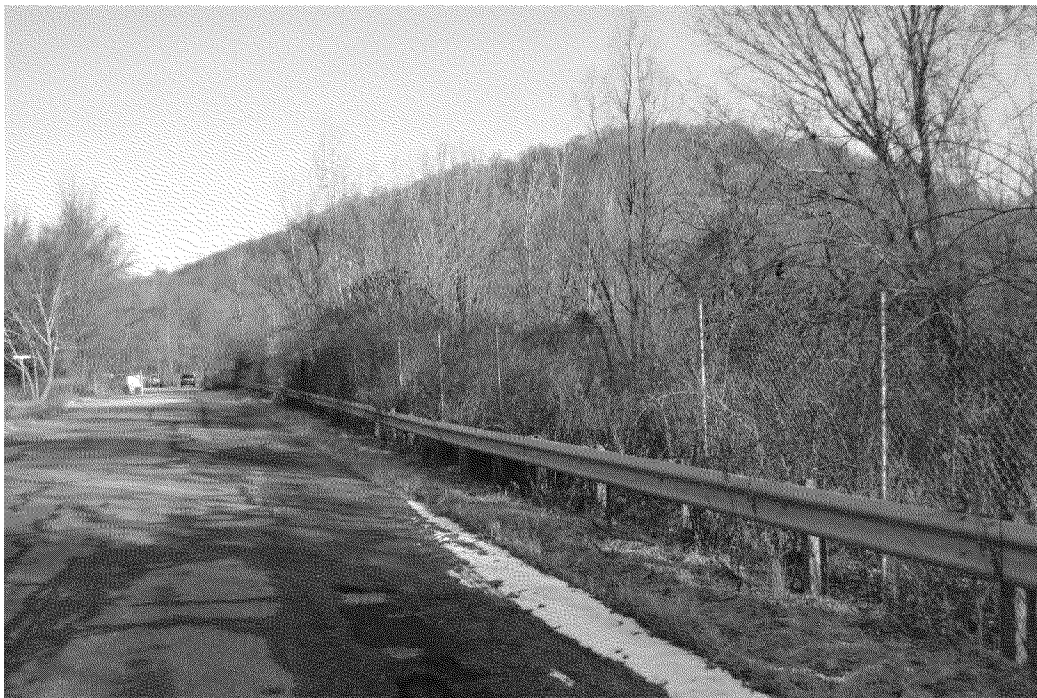
**Photograph 6.** OCDA—Chain link fence along Peters Mine Road marking western edge of the remediation area. PMP Area is at far left in distance. Hope Mountain is in background to right. Looking north. Photo by C.L. Borstel, Tetra Tech, Inc., January 16, 2017.

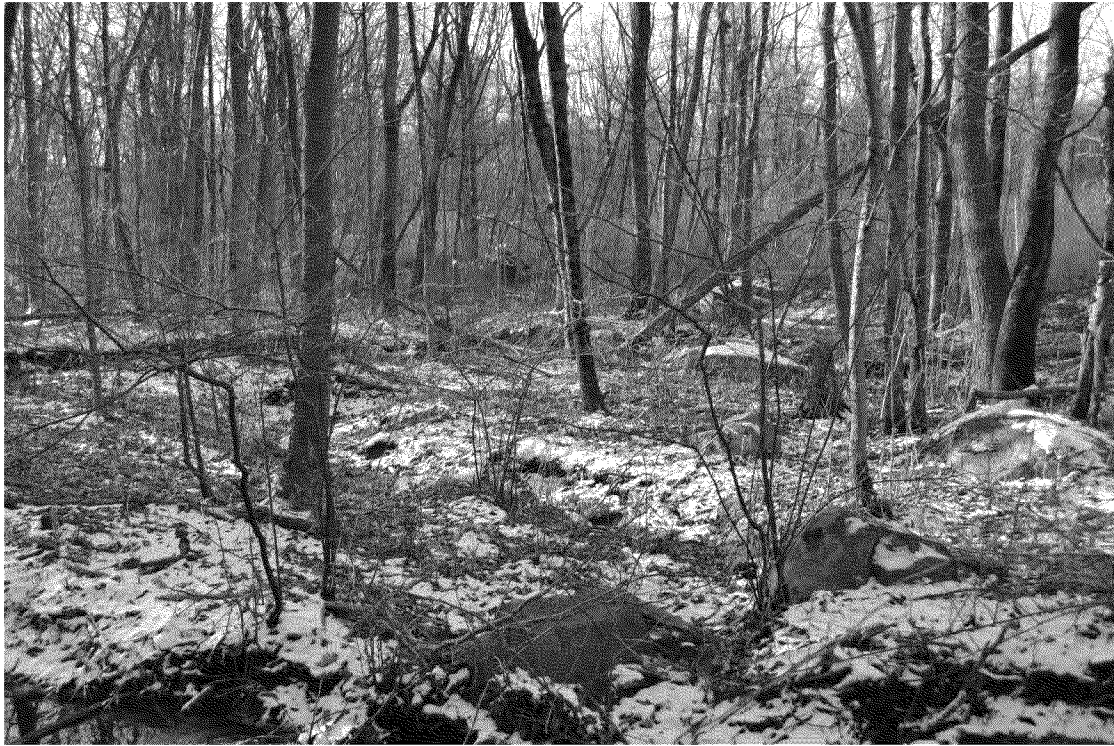
**Photograph 7.** OCDA—Wooded wetland outside northeastern edge of area, looking toward OCDA. Looking southwest. Photo by C.L. Borstel, Tetra Tech, Inc., January 16, 2017.

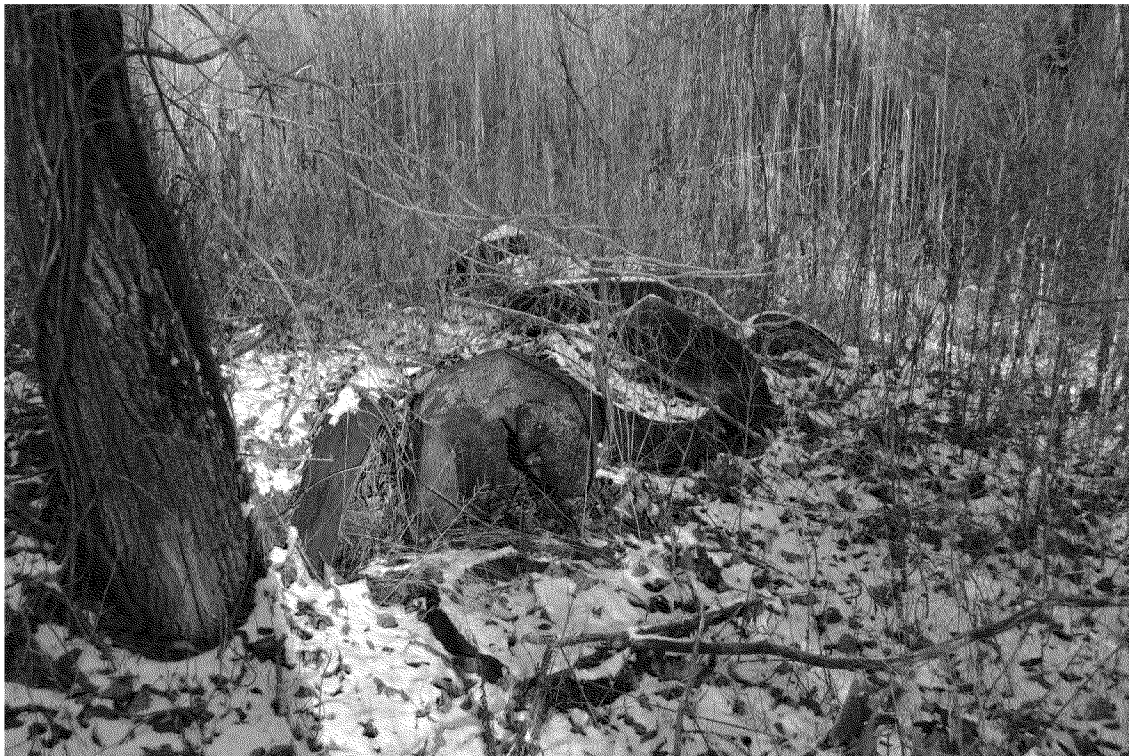
**Photograph 8.** OCDA—Typical hummocky terrain and thick vegetation in the central part of the area. Note debris on the surface. Looking northwest. Photo by C.L. Borstel, Tetra Tech, Inc., January 16, 2017.

**OCDA:** This area almost immediately adjoins the PMP Area on the southeast. While Peters Mine was in operation, this area was used as a sluice pond to dewater and deposit mine tailings. The ground slopes eastward from Peters Mine Road toward a stream and wetlands area that mark the eastern edge of the land AC. As at the PMP Area, many areas of ground are hummocky, and there is a combination of rock piles, likely mine tailings, and debris in piles and scattered across the surface, such as tires and metal. The western and central parts of this land AC are mostly upland woods—predominantly pole-size trees (implying no more than a few decades of growth), while the eastern portion is lower and a mix of open tall reeds and grasses and wooded wetland. One area near the southern end of the land AC, covering approximately 75 by 250 feet, was clearly visible as a location where prior excavations for remediation had taken place. Such excavations and those related to trenching for evaluation of soil characteristics occur in many parts of the OCDA. The OCDA contains no building remnants.

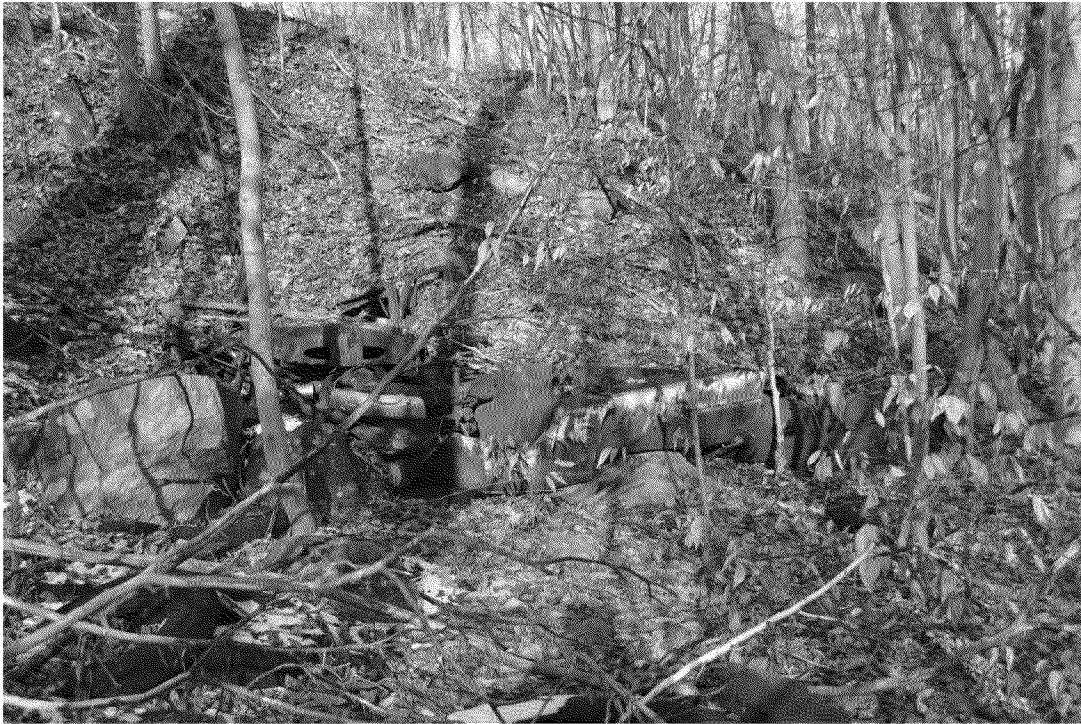
**Photograph 9.** OCDA—Typical sloping terrain and thick vegetation in the southern part of the area. Note surface-exposed angular boulders, some or all of which may be mine tailings, and the metal debris on the surface. Looking northwest. Photo by C.L. Borstel, Tetra Tech, Inc., January 16, 2017.

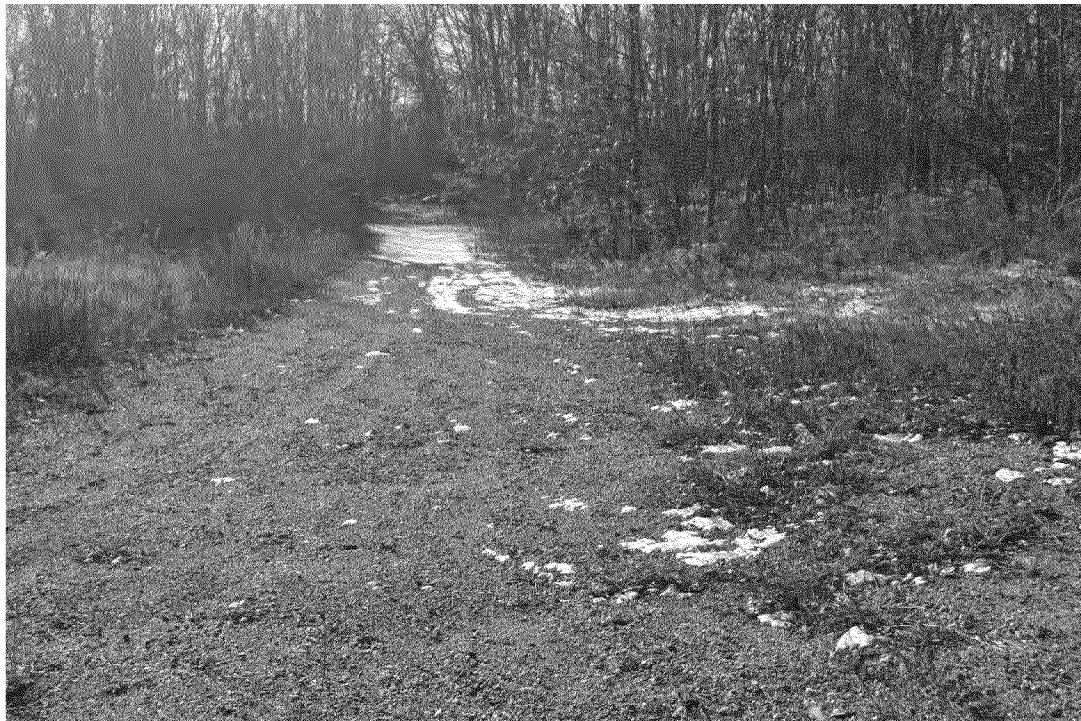
**Photograph 10.** CMP Area—View from vicinity of remediation area of existing gravel access road that connects to the end of Horseshoe Bend Road to the area. Looking south. Photo by C.L. Borstel, Tetra Tech, Inc., January 16, 2017.

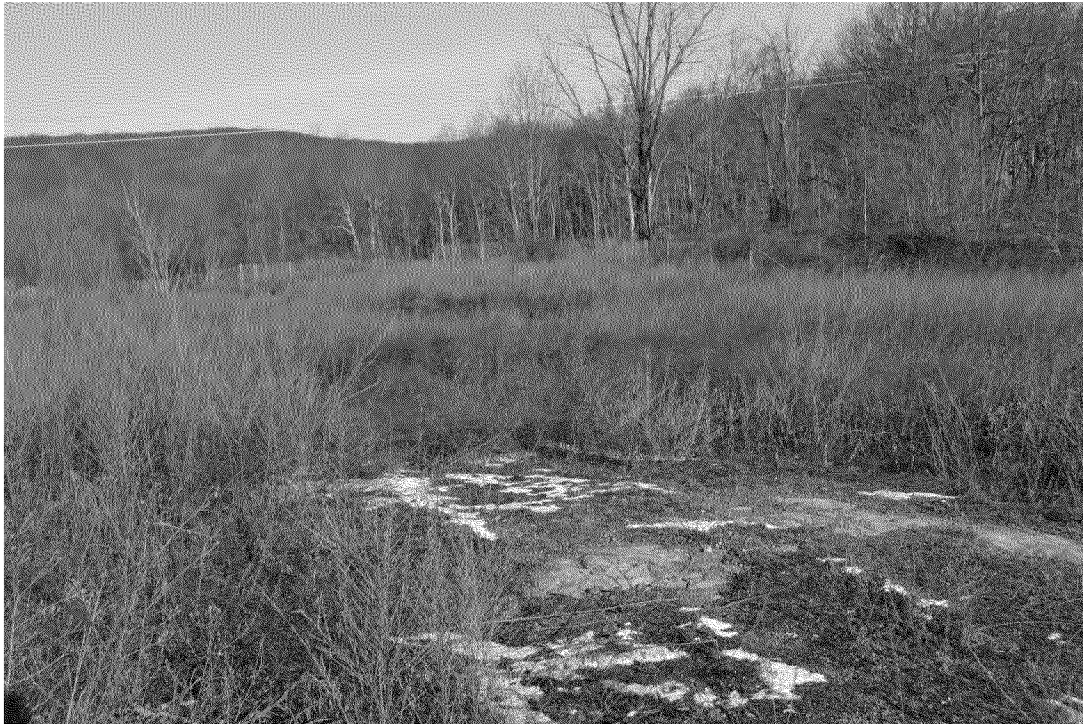
**Photograph 11.** CMP Area—View from southern edge across area. Looking north. Photo by C.L. Borstel, Tetra Tech, Inc., January 16, 2017.

**CMP Area:** This area is situated approximately 1 mile south of the PMP and OCDA Areas. Approximately 300 to 450 feet east of the location of the planned location of the CMP Area remediation and restoration activities, at the intersection of Van Dunk Lane and Milligan Lane, there is a fenced mine shaft, which was part of Cannon Mine. New fencing had been recently installed around it. The CMP Area is accessed by an approximately 600-foot gravel access road in good repair that runs from the end of Horse Shoe Bend Road to the CMP Area. The area where remediation and restoration will take place is on a ridge spur overlooking a small stream. No trees were present within the fenced CMP Area, and examination of aerial photographs indicated that trees were removed from the entire area for remediation investigations that were conducted at CMP between approximately 2007 and 2009. The surface of the CMP Area gently slopes to the northwest—i.e., toward the edge of the valley overlooked by this land AC. The evenness of the slope and lack of any surface debris or topographic irregularities other than one or two piles of very large boulders indicates the area was extensively graded. The rock piles were not mine tailing remnants but were probably imported to the location for landscaping or access management. One fenced area at the eastern end of the CMP Area is a subsurface void, but owing to thick vegetation within and around the fence, it was difficult to get a clear view of the feature. Otherwise, the CMP Area contains no aboveground ruins or foundations on the surface, and judging by the evidence of previous remediation activities and grading, it is unlikely that archaeological traces of any such features have been preserved.

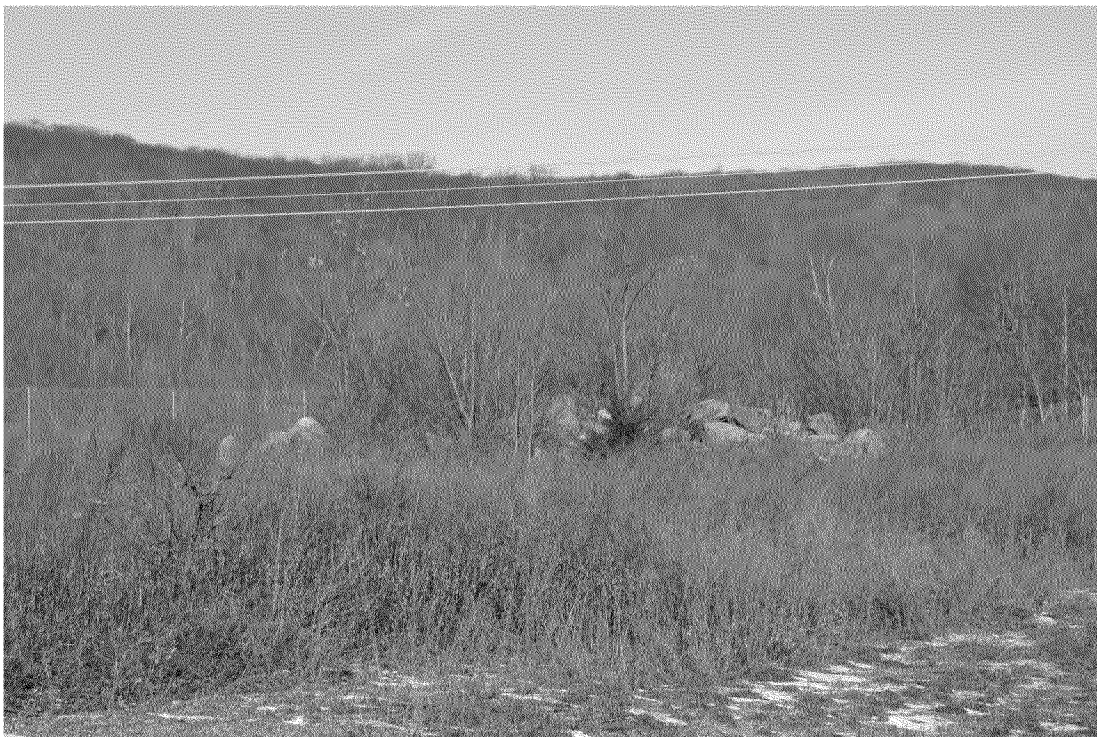
**Photograph 12.** CMP Area—Non-structural pile of boulders at western end of area. Looking northwest. Photo by C.L. Borstel, Tetra Tech, Inc., January 16, 2017.

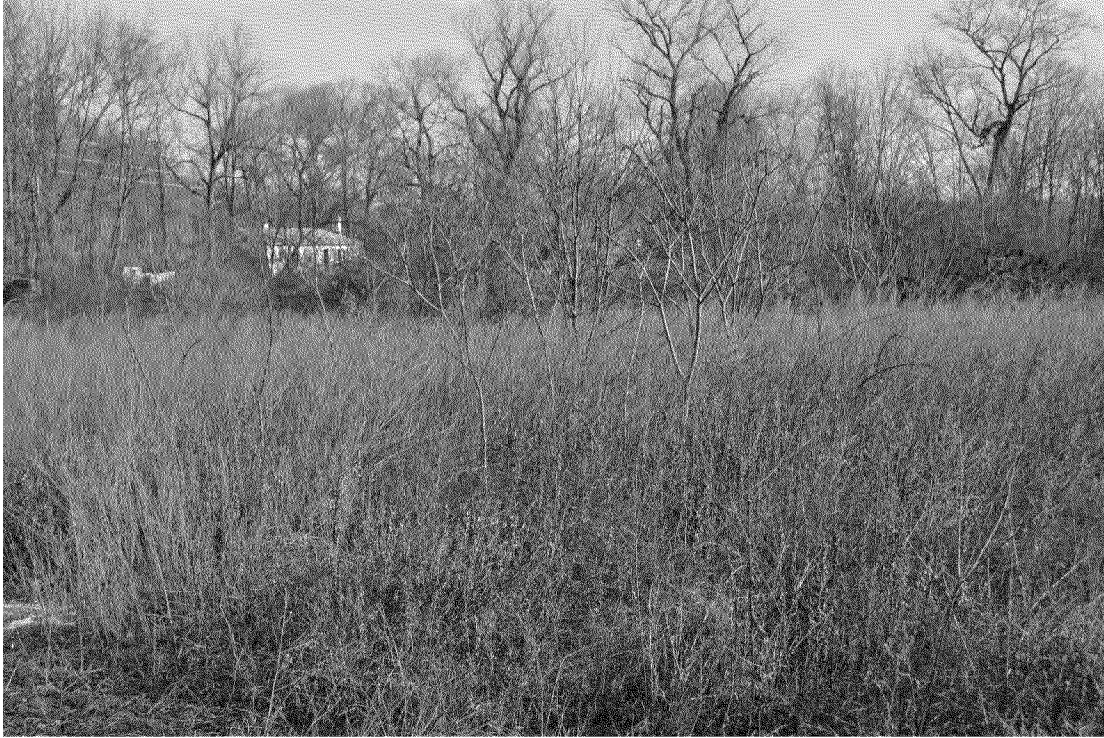
**Photograph 13.** CMP Area—Typical terrain and vegetation of eastern part of area looking toward Van Dunk Lane. Looking northeast. Photo by C.L. Borstel, Tetra Tech, Inc., January 16, 2017.
